**Flood Control Project Maintenance
Levee Inspections**
LMA District Cover Sheet
Spring 2018 Levee Inspection Results

Reclamation District No. 1500 Sutter Basin

Spring 2018 Levee Inspection Results

Waterway			Bank	Unit Miles
Unit No. 01 Sacramento River			Left	33.15
	Spring (March - May)	Summer (June - August)	(September - November) Fall	Winter (December - February)
Unit Maintenance Rating (Fall Only)				
Date of Inspection	3/27/2018 - 3/28/2018			
DWR Inspector	Zach Jojola			
Accompanied By	Hiromi Tomita RD 1500

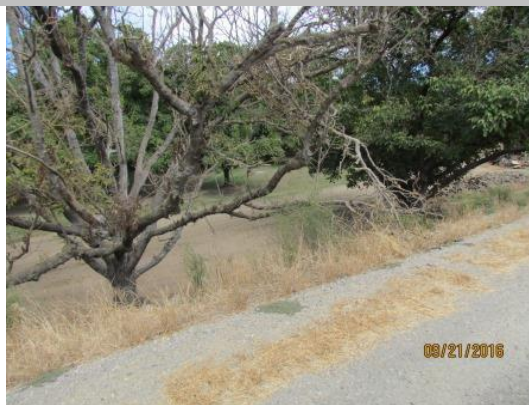
Photo 2 of 2 : SP_2018_RD1500_189_137_20180306_00072.jpg

A tree on landside slope needs trimming. Fall 2016.

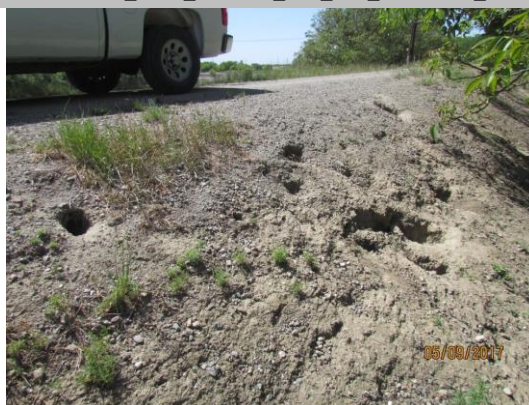
Photo 1 of 1 : SP_2018_RD1500_189_152_20180306_00078.jpg

View of rodent holes on landside slope. Spring 2017.

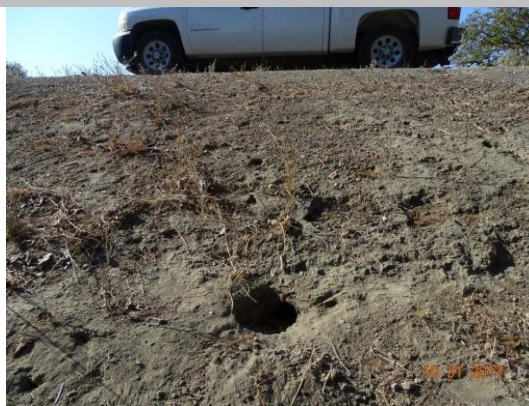
Photo 1 of 2 : SP_2018_RD1500_189_135_20180306_00070.jpg

Update view of hole on landside slope. Fall 2017.

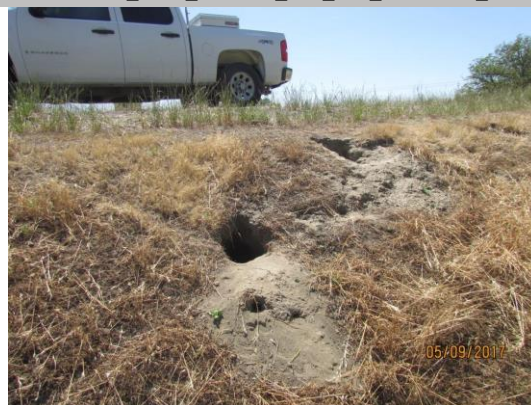
Photo 1 of 1 : SP_2018_RD1500_189_149_20180306_00076.jpg

View of rodent holes on landside slope. Spring 2017.

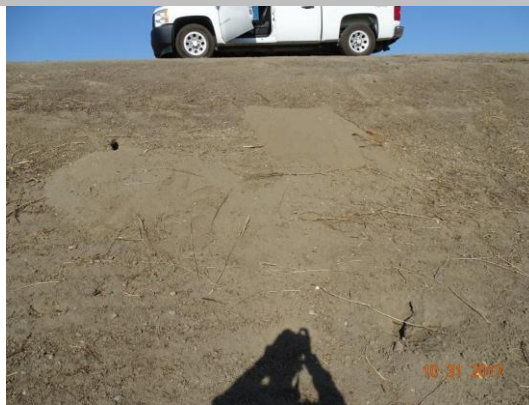
Photo 2 of 2 : SP_2018_RD1500_189_99_20180306_00050.jpg

View of holes and mounds on landside slope. Fall 2017.

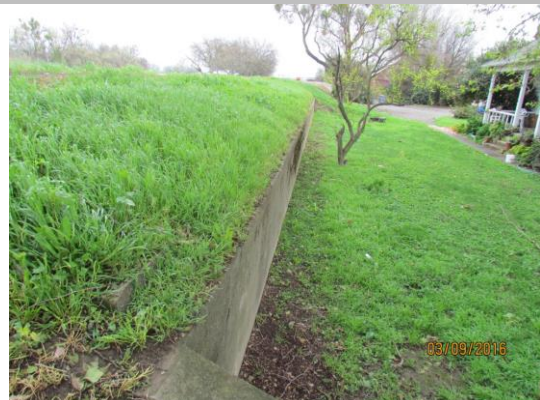
Photo 1 of 1 : SP_2018_RD1500_189_4_20180306_00004.jpg

View of the retaining wall that is in USACE as-builts on the landward side of the levee looking upstream. Wall cuts into levee toe. Spring 2016.

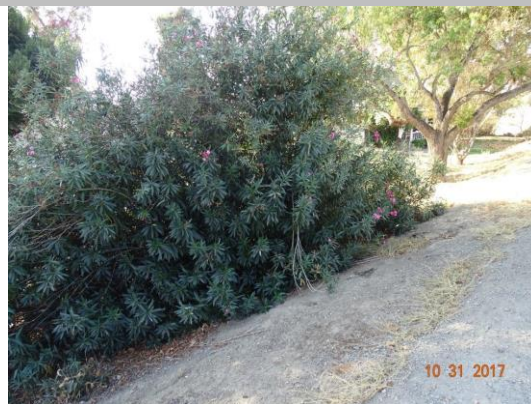
Photo 1 of 1 : SP_2018_RD1500_189_98_20180306_00049.jpg

View of vegetation on landside slope. Fall 2017.

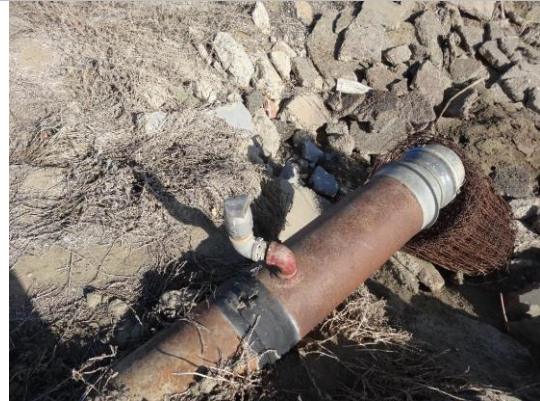
Photo 3 of 3 : UCIP_SP_2018_28264_51969.jpg

LS view: plugged discharge pipe with air vent across irrigation ditch on landside.

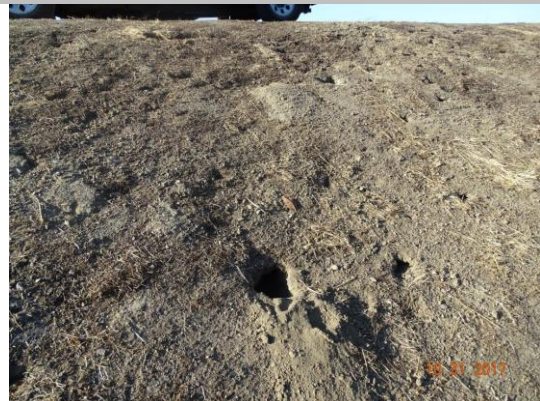
Photo 1 of 1 : SP_2018_RD1500_189_93_20180306_00047.jpg

View of hole on landside slope. Fall 2017.

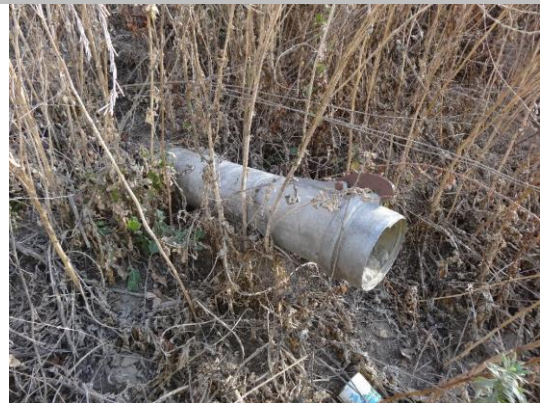
Photo 2 of 3 : UCIP_SP_2018_28323_52124.jpg

WS view: abandoned steel pipe exposed on river bank.

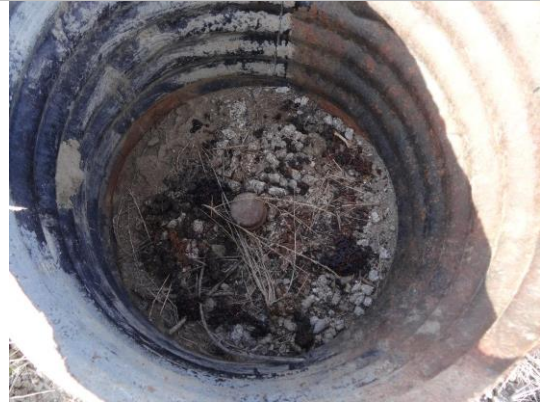
Photo 3 of 3 : UCIP_SP_2018_28925_53208.jpg

LS view: obstructed siphon breaker in CMP riser (bottom) on levee slope.

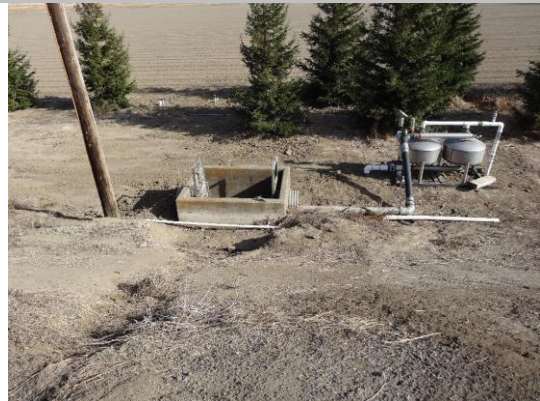
Photo 2 of 3 : UCIP_SP_2018_50198_52219.jpg

LS view: depressions along the pipe alignment on levee slope. It needs detailed investigation.

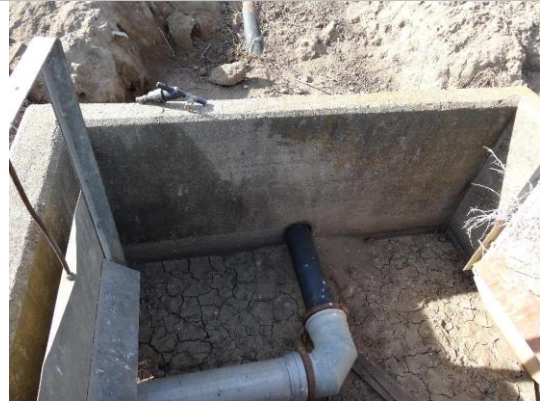
Photo 3 of 3 : UCIP_SP_2018_50198_52221.jpg

LS view: concrete distribution box on levee toe. Exposed pipe and depression (top) visible on levee slope.

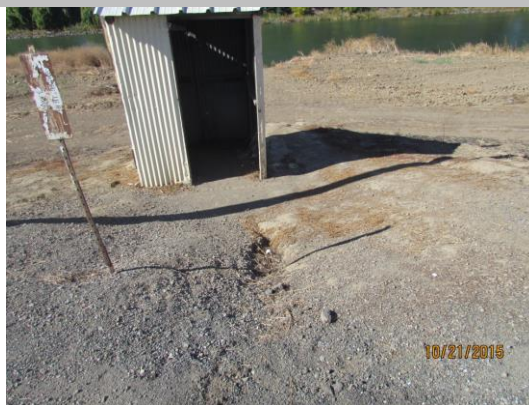
Photo 3 of 3 : SP_2018_RD1500_189_114_20180306_00060.jpg

There is slight erosion on the waterward side of the levee where the pipe seems to run through the levee. Fall 2015.

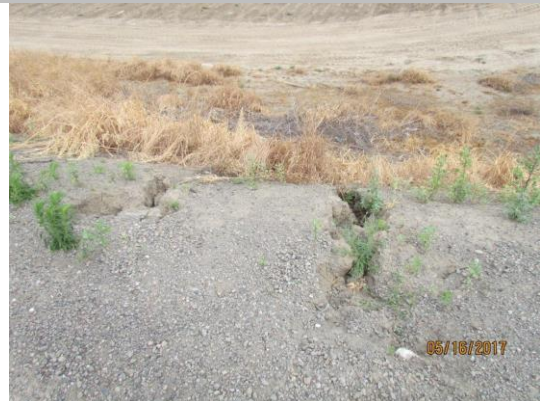
Photo 1 of 1 : SP_2018_RD1500_189_116_20180306_00061.jpg

View of erosion on landside slope. Spring 2017.

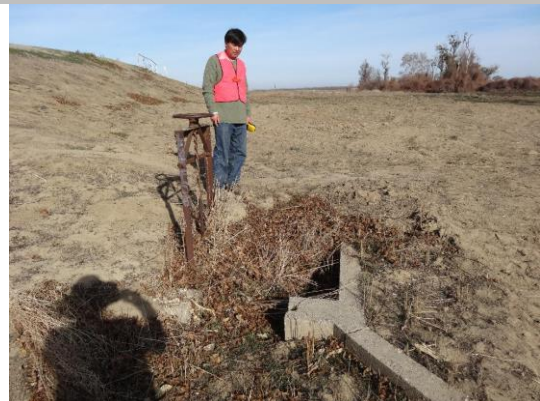
Photo 1 of 3 : UCIP_SP_2018_50197_52425.jpg

WS view: slide gate (left) in concrete box at levee toe. Slide gate and the box mostly buried.

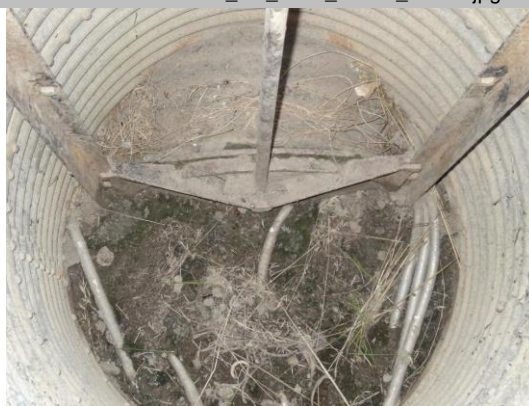
Photo 2 of 3 : UCIP_SP_2018_28489_52478.jpg

WS view: cleaning and clearing require around slide gate in CMP riser.

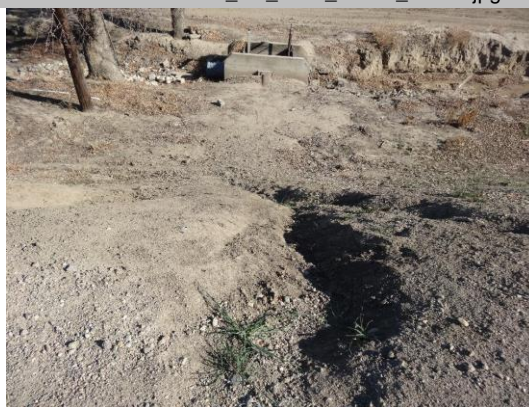
Photo 2 of 3 : UCIP_SP_2018_28506_52522.jpg

LS view: surface erosion on landside levee slope.

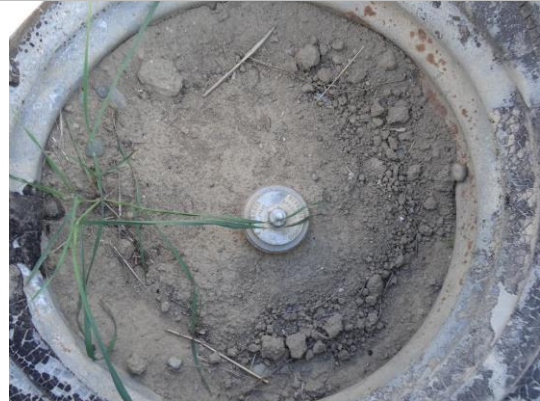
Photo 3 of 3 : UCIP_SP_2018_28527_52566.jpg

LS view: obstructed siphon breaker in CMP riser on levee slope.

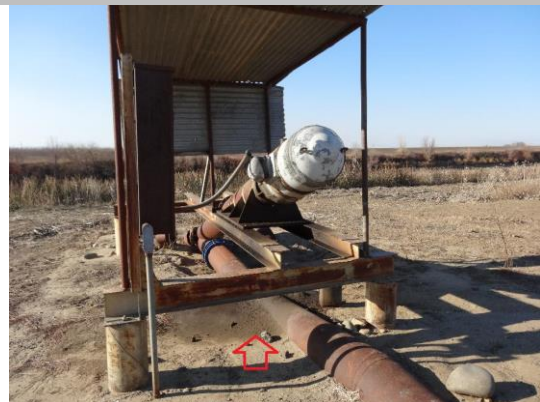
Photo 2 of 3 : UCIP_SP_2018_28586_52642.jpg

WS view: slant pump on steel platform on levee berm. Oil leaks from the pump (marked). Exposed pipe on the berm.

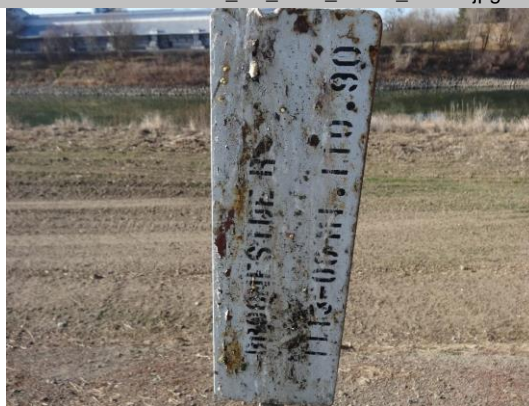
Photo 1 of 2 : UCIP_SP_2018_41728_52673.jpg

WS view: utility tag plate on waterside shoulder. No pipe found.

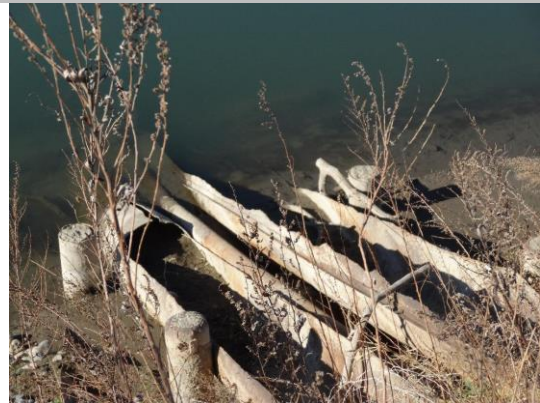
Photo 1 of 2 : UCIP_SP_2018_28629_52709.jpg

WS view: abandoned 24" and 30" steel pipe on river bank.

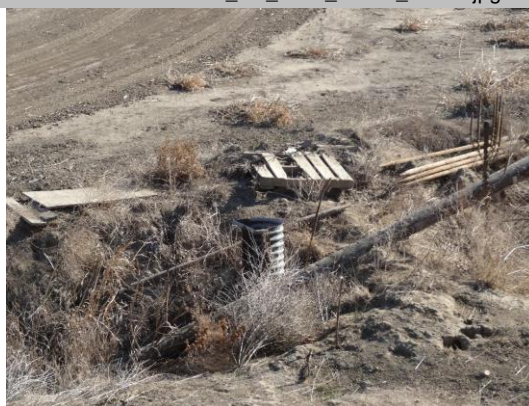
Photo 2 of 2 : UCIP_SP_2018_28629_52708.jpg

LS view: abandoned CMP risers on levee toe.

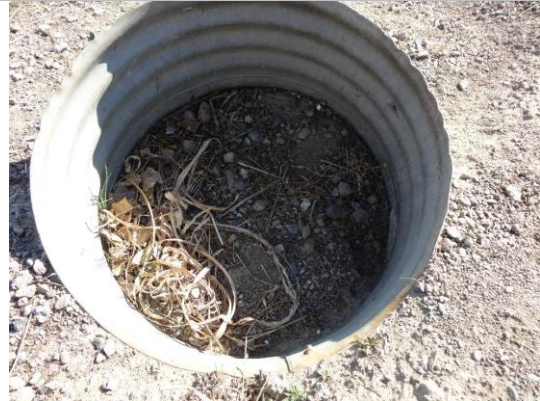
Photo 3 of 3 : UCIP_SP_2018_28631_52721.jpg

LS view: obstructed siphon breaker in CMP riser on levee slope.

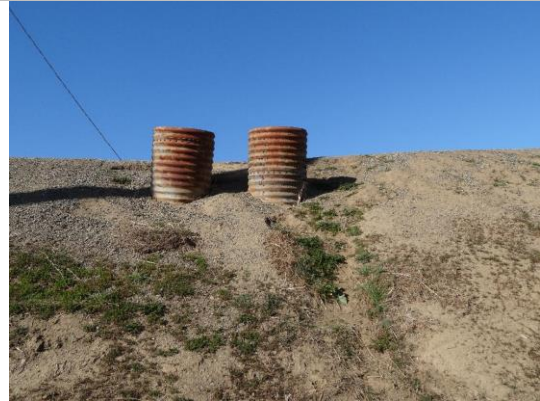
Photo 2 of 3 : UCIP_SP_2018_50194_51833.jpg

LS view: CMPs with leaky siphon breakers. Slope erosion and excessive vegetation on levee slope.

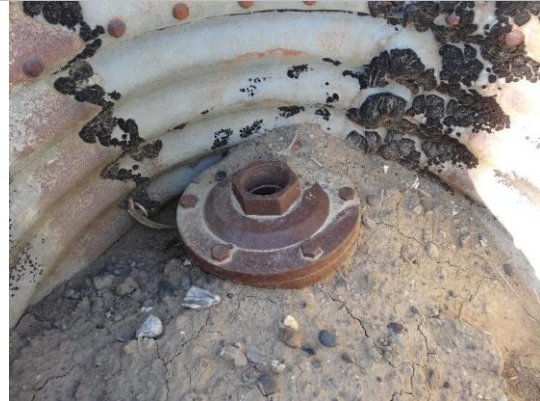
Photo 3 of 3 : UCIP_SP_2018_50201_52853.jpg

LS view: obstructed and leaky siphon breaker in CMP riser on levee slope.

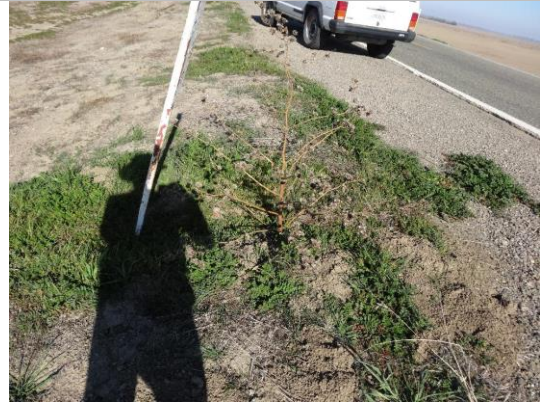
Photo 3 of 3 : UCIP_SP_2018_50193_51825.jpg

WS view: excessive vegetation along pipe alignment on levee slope.

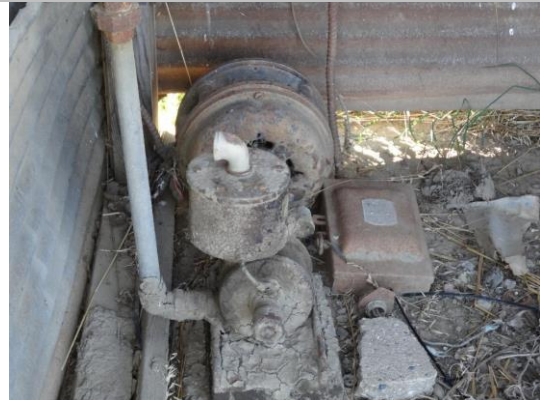
Photo 1 of 3 : UCIP_SP_2018_28144_51812.jpg

WS view: pump in CM pump house on levee shoulder. Looks abandoned.

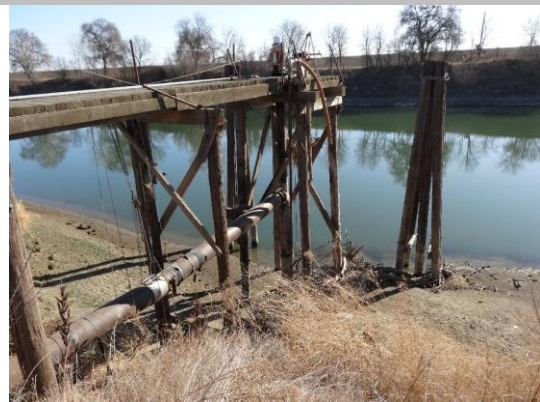
Photo 2 of 3 : UCIP_SP_2018_28143_51804.jpg

WS view: abandoned walkway, pipe, and pump on river bank.
